Testing robustness: A full-scale experimental test on a two-storey reinforced concrete frame with solid slabs

Alejandro Pérez Caldentey ^{a,b,*}, Yolanda G. Diego ^a, Freddy Ariñez Fernández ^b,
Anastasio P. Santos ^a

This paper presents the results of a full-scale robustness test carried out on a two storey building with two square reinforced concrete slabs (25 cm deep) with a span of 6.6 m, in which a corner column was suddenly removed. Despite the extreme action, and the fact that the slab was not designed for it, only relatively minor damage was observed, with a maximum deflection around 22 cm and apparently controlled cracking patterns. The slab started working as a simply supported element along the symmetry axis of the structure supported on only 3 columns. The tests were modeled using Finite Element Analysis. It was observed that the model could capture very well the behaviour of the real structure, predicting very similar cracking patterns and deflections. The structure was shored two hours after the test because deflections were not yet fully stabilized. It is suspected that this increase of deflections could be related to the deterioration by torsional effects of the c

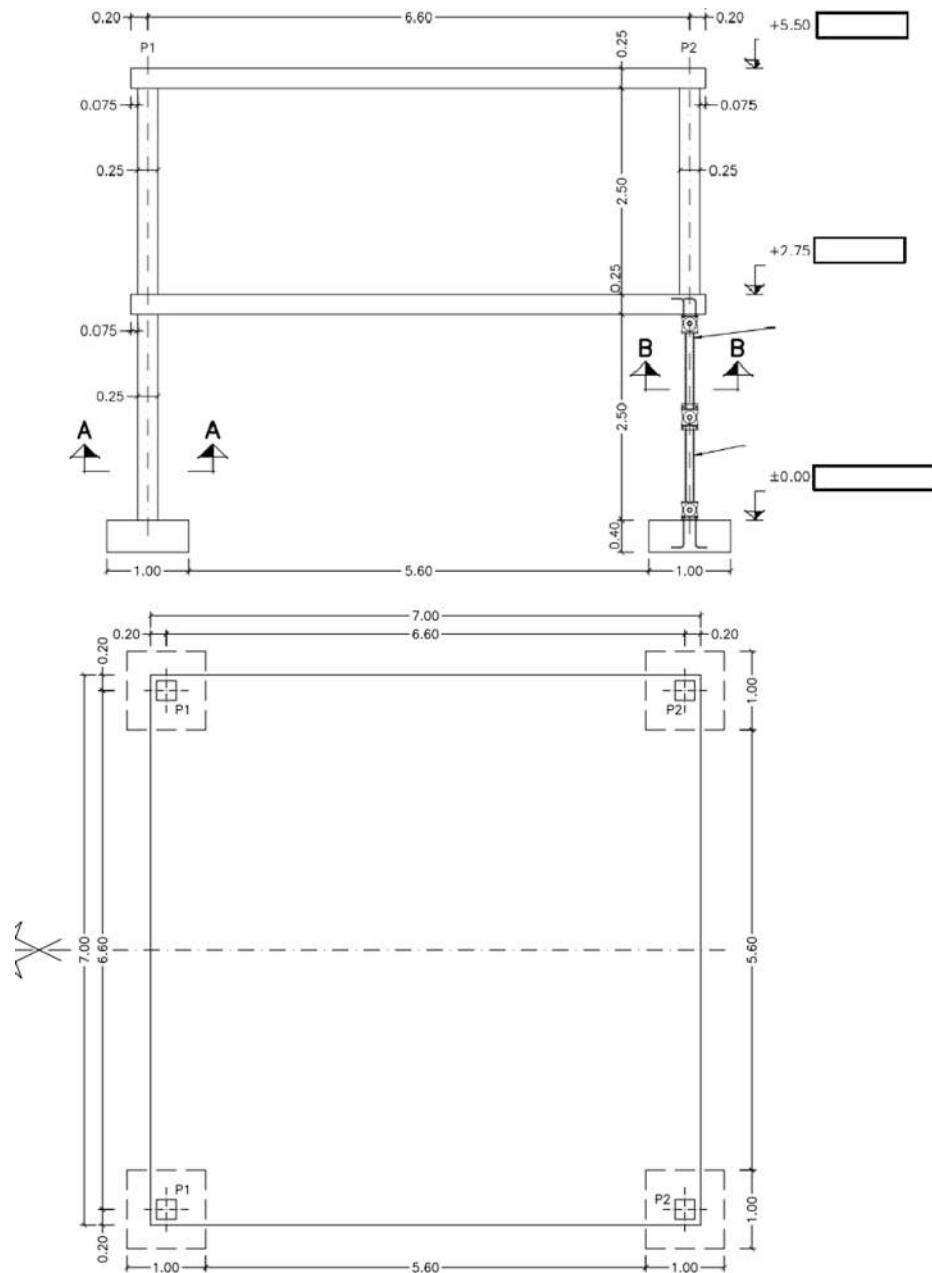
Fig. 1. Structure elevation and plan view.

The structure consists of two 25 cm slabs with external dimensions of 7x7 m², supported on 4 columns with spans of 6.60 m. As can be seen in

Fig. 1, the supports are $25 \times 25 \text{ cm}^2$ reinforced concrete elements, with the exception of one of those going from the foundation to the first storey. This support is made by two welded UPE-100 profiles and is equipped with 3 hinges and a mechanism to block the central hinge, to guarantee stability during construction.

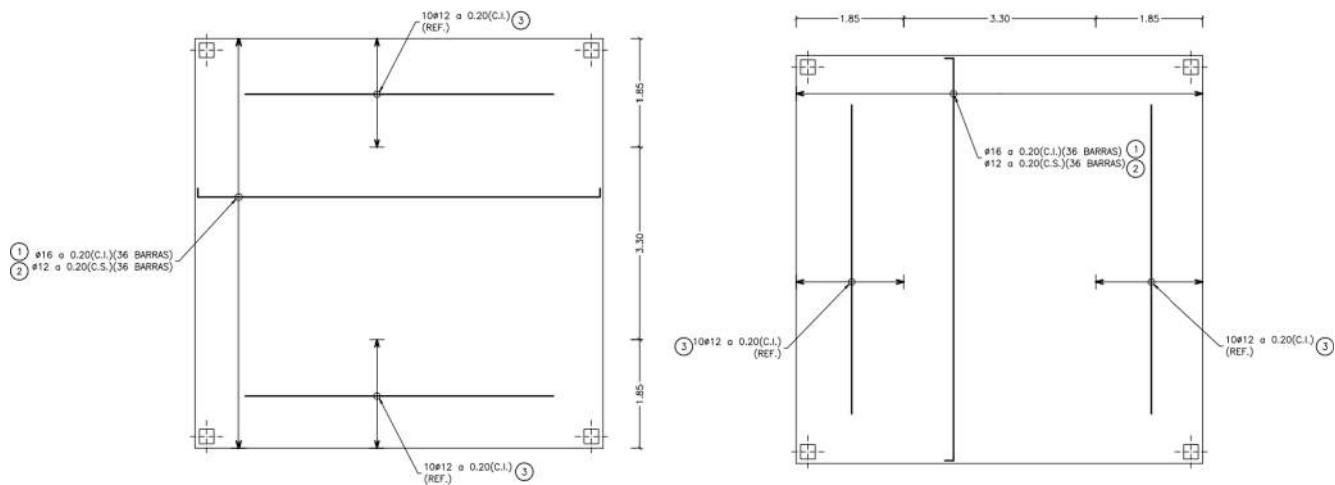
Fig. 2. Slab reinforcement.

The flexural reinforcement of the slabs is shown in Fig. 2. It consists in a 16 mm bar mesh spaced at 20 cm placed on the bottom of face and a 12 mm bar mesh spaced at 20 cm placed on the top face. Additionally a supplementary reinforcement for positive bending consisting in 12 mm bars spaced at 20 cm is placed on the bottom face in the column strip (1/4 of the transversal span in the vicinity of the columns). Additionally, punching reinforcement is provided as shown in Fig. 3. Punching

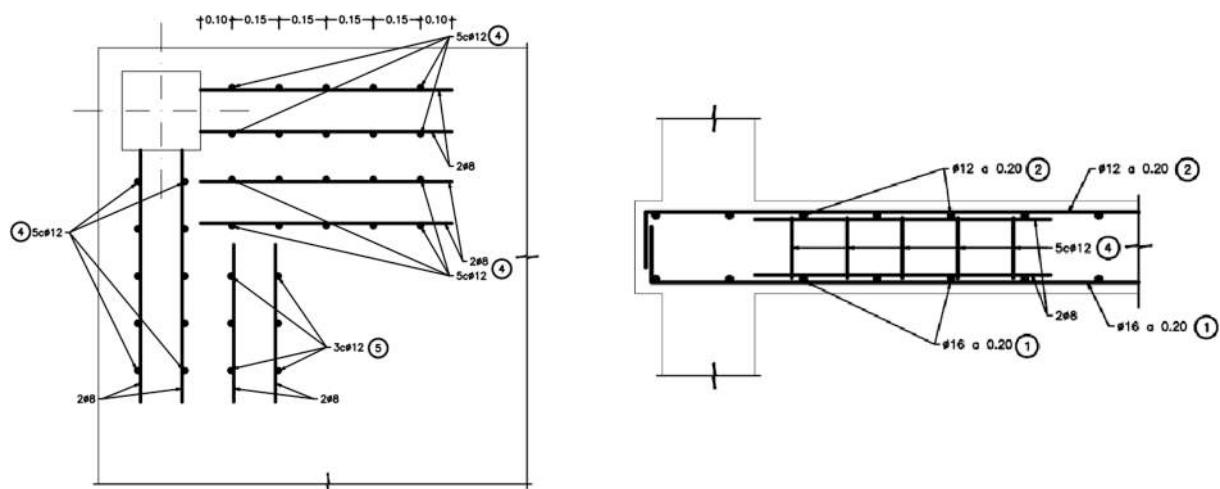
Fig. 3. Punching reinforcement (left: plan view; right: elevation).

reinforcement consists in a total of eighteen 12 mm links. The detail used is unconventional from a theoretical point of view, since the links do not embrace the main flexural reinforcement (instead they are held together by auxiliary 8 mm bars), but this is a detail commonly used in construction and there is experimental evidence that it functions properly [26]. It was decided to use this detail to account for actual construction practices.

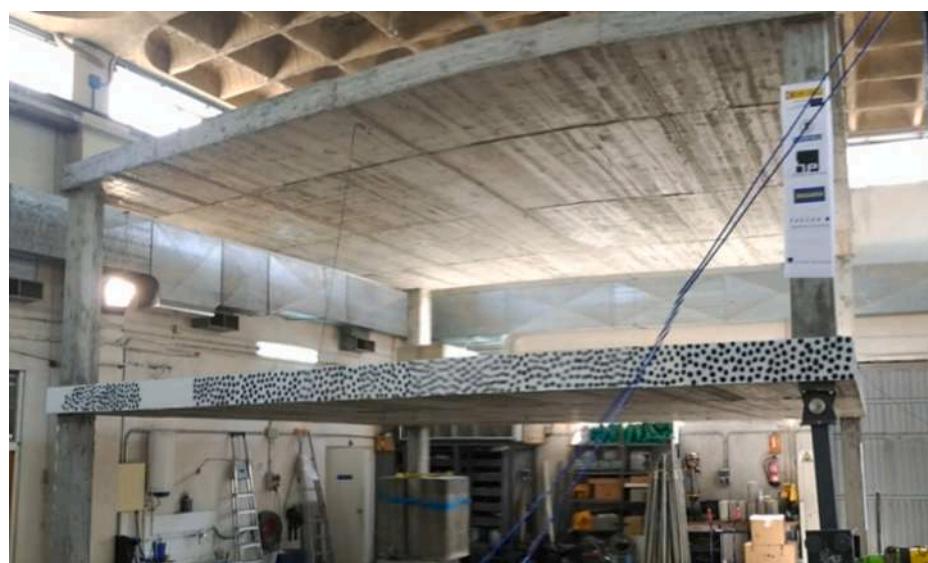
Fig. 4. View of the structure built inside the laboratory.

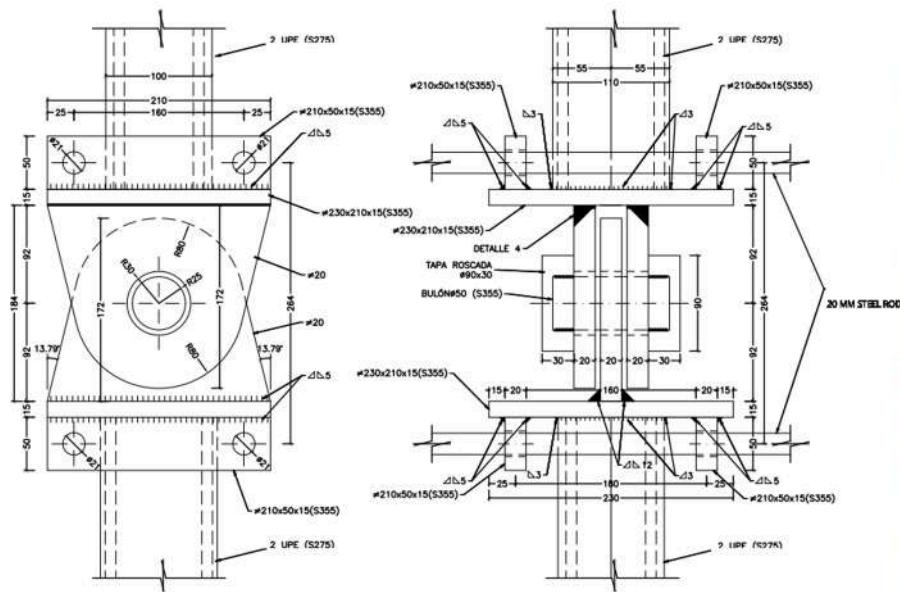
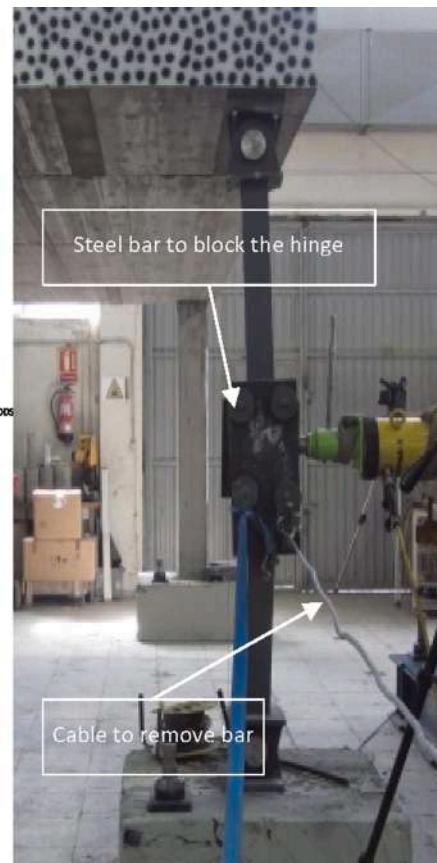
Fig. 5. Detail of central column hinge and view of the built specimen.

The test was carried out on May 4th, 2016. To carry out the test a hydraulic jack (yellow jack in Fig. 5) was placed in series with a manual jack (green jack in Fig. 5) at the point of the central hinge on the steel support. The manual jack was used to achieve good contact and a minimum level of pressure between the jack and the support. The steel support was designed so that it would be built with a slight rotation at the central hinge, so that the jack would serve as a support for the structure once the central hinge was liberated.

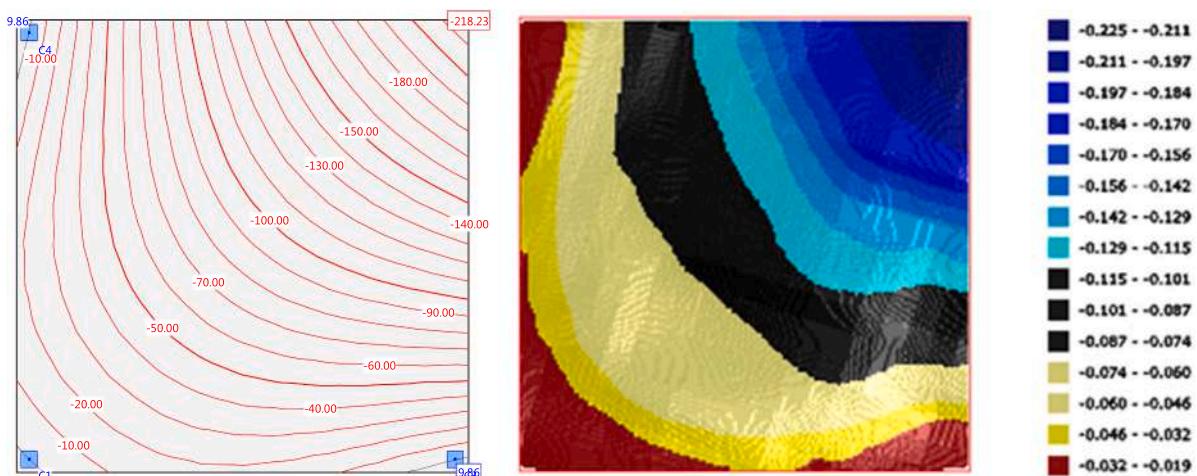
Fig. 6. Left: Deflections assuming a cracked stiffness (in millimeters). Right: Measured deflection in meters.

Fig. 6 shows a comparison of this approximation to the actual measured slab deformation. It can be seen that a very good approximation is obtained using this method. Errors that tend to overestimate

the deflection (no consideration of Tension stiffening effects) compensate with errors that tend to underestimate the deflection (assumption that all the slab is reinforced uniformly with the reinforcement of the column strip). This approximation could, of course be refined by discriminating the stiffness by zones and by applying a method to account for tension-stiffening, such as the ζ -method [9]. Instead, in the next paragraph a more rigorous analysis using LS-DYNA will be presented. In any case, this very simple analysis shows that the behaviour of the structure is not far from that of cracked behaviour of reinforced concrete, without significant plastic deformations, which, in itself, is surprising given the action. This is also supported by the cracking pattern of the underside of the slabs which is mainly a well-controlled serviceability-type cracking pattern (see paragraph 5).

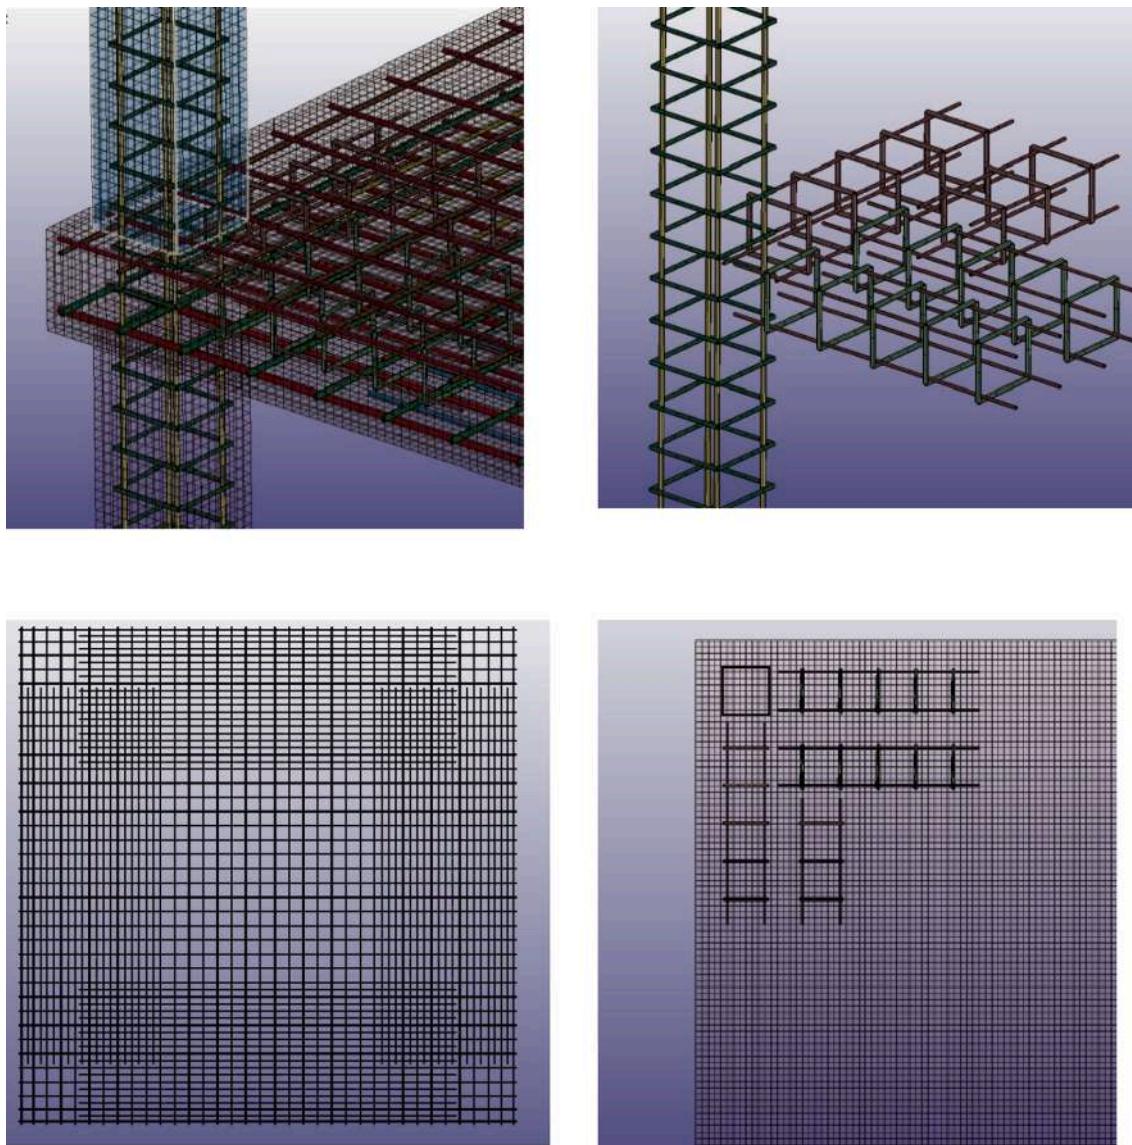
Fig. 7. FEM model details.

Fig. 7 shows details of the model where the size of the concrete elements (2.5 cm) as well as the modelling of the reinforcement can be seen. Fig. 8 shows a global view of the LS-DYNA model.

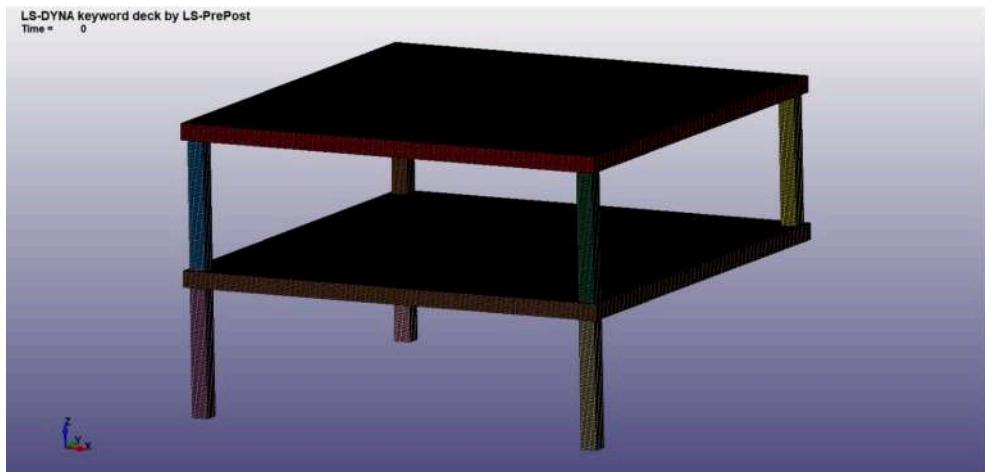
Fig. 8. FEM model.

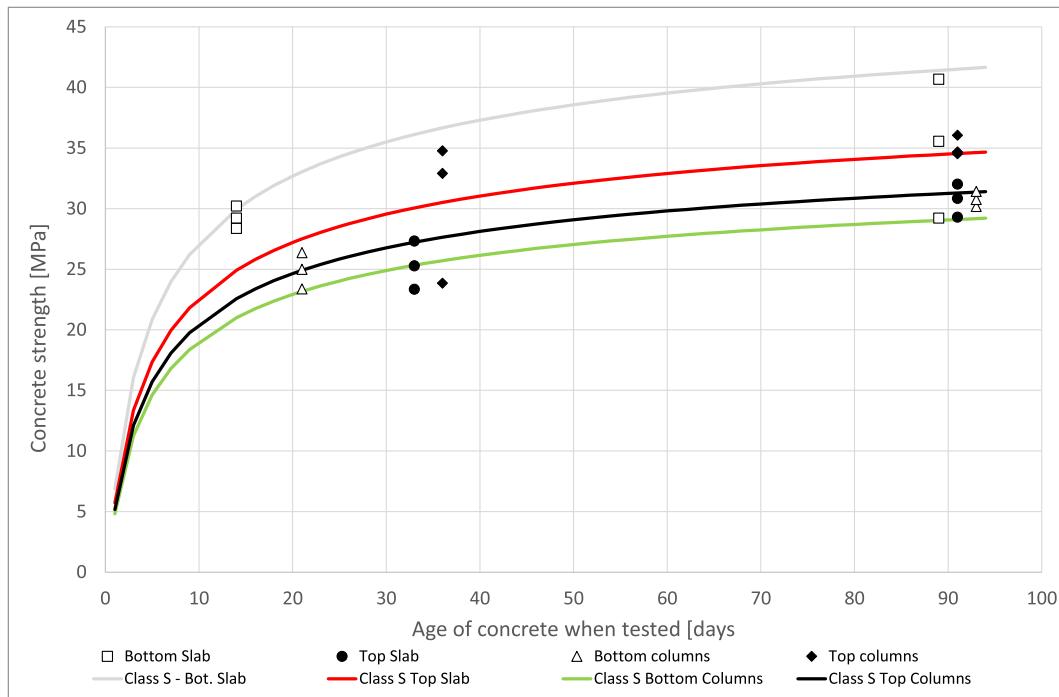
Fig. 9. Measured concrete resistance and estimated evolution in time.

Table 4 shows the estimated concrete strength of each element on the day of the test. These values were estimated by using the equations for the evolution of concrete strength with time according to [9], assuming a value of $s = 0.38$ for a Class S cement, as shown in Fig. 9. In the figure the test results are also plotted using symbols.

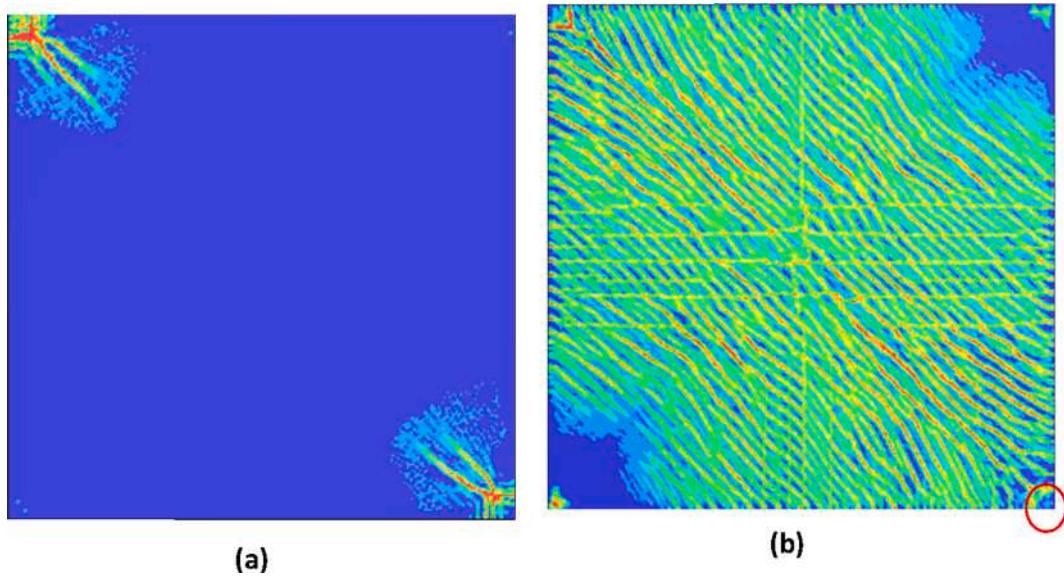
Fig. 10. FEM crack pattern of Top Slab: Top view (a) and (b) Bottom view.

This section presents a comparison between the observed damage at the end of the test and the peak tensile strain concentrations from the LS-DYNA model. Although the LS-DYNA concrete material model does not explicitly show the cracks that form on the surface, a reasonable approximation of crack location can be obtained by plotting the maximum principal strain at the solid integration points used to model the concrete material (eight node solid elements). Fig. 10 and Fig. 11 show the cracking patterns predicted by LS-DYNA on the top and bottom surfaces of the top and bottom slab, respectively. The crack pattern in the bottom face of the slab is consistent with those of a slab working in sagging flexure along an axis with a span length corresponding to the diagonal line perpendicular to the symmetry axis. The diagonal cracks radiating from the supports on the top of the slab are compatible with those on a cantilever spanning parallel to the symmetry axis of the structure. This type of behaviour is also illustrated in [21] – see Fig. 12.

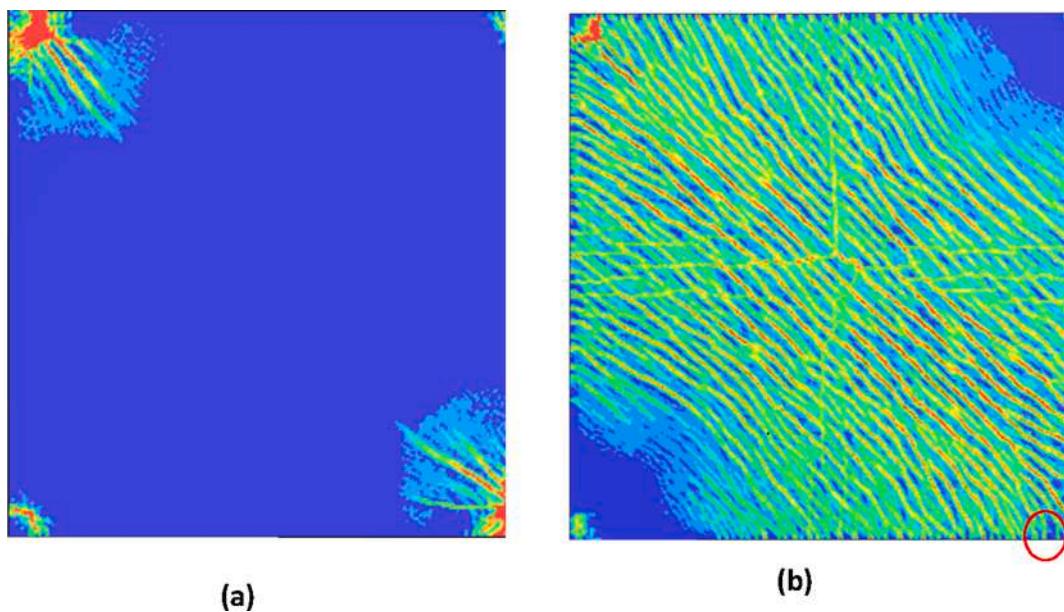
Fig. 11. FEM crack pattern of Bottom Slab: Top view (a) and (b) Bottom view.

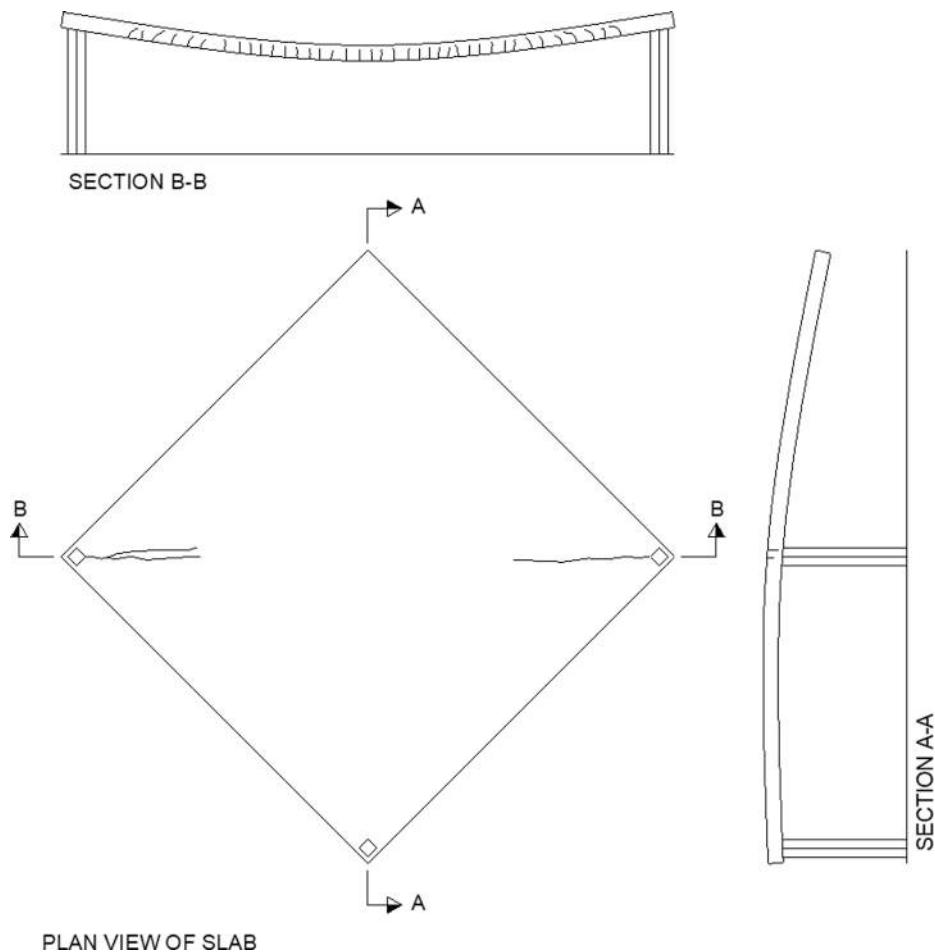
Fig. 12. Deformation and cracking pattern (conceptual scheme). Cantilever behaviour along A-A and simply supported behaviour along section B-B. Vertical deflections exaggerated.

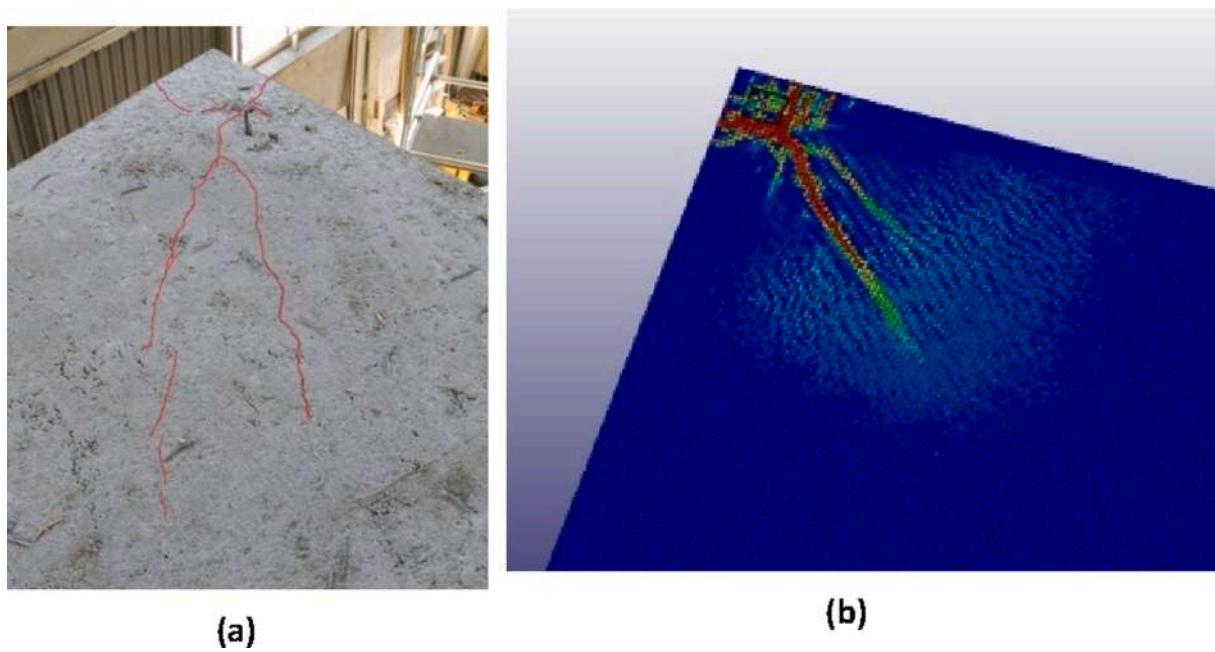
Fig. 13. Test (a) and FEM (b) top corner crack pattern.

Fig. 13 and Fig. 14 show a comparison between the cracking pattern predicted by the FEM and the pattern observed in the test, it is evident that both patterns are very similar.

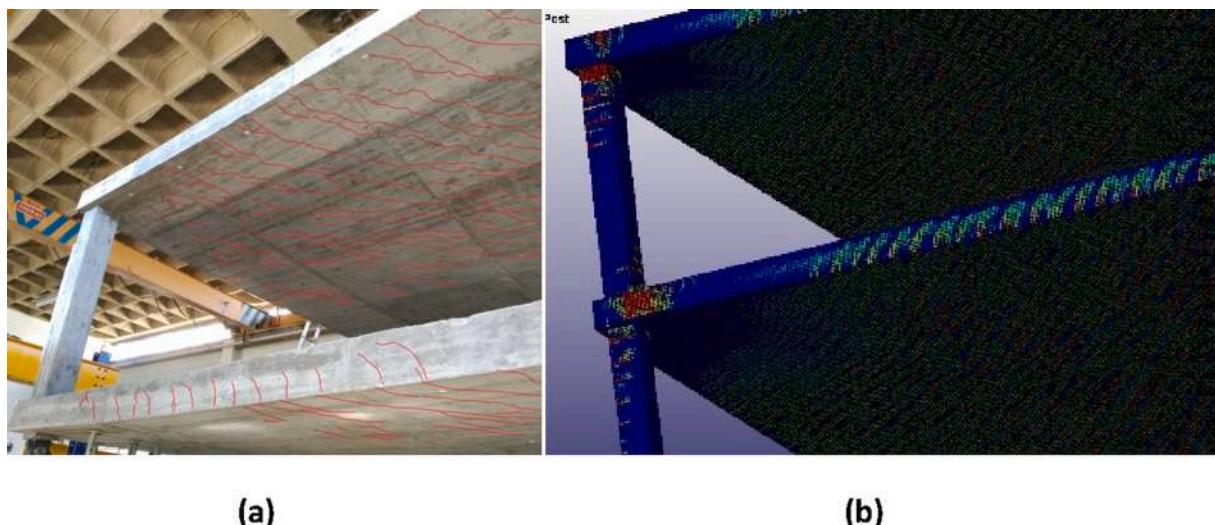
Fig. 14. Test (a) and FEM (b) top slab crack pattern.

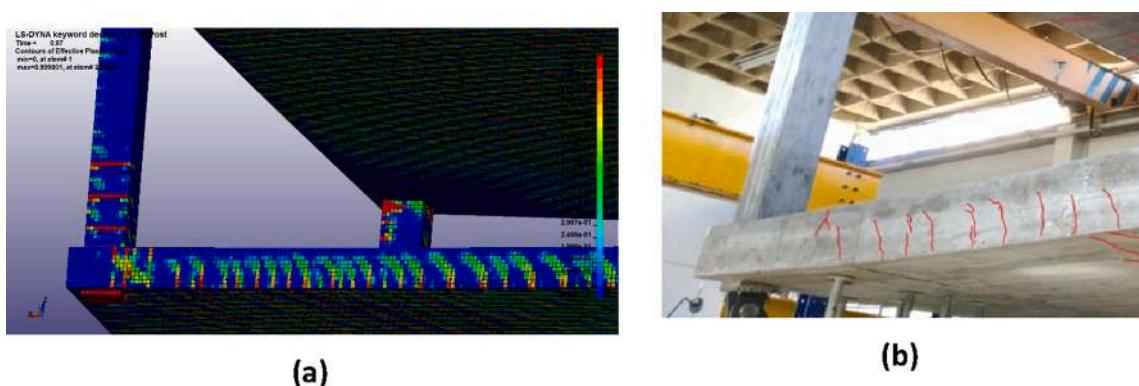
Fig. 15. Test (a) and FEM (b) slab crack pattern.

Fig. 15 shows the cracking pattern along the edge of the slabs. These are torsional cracks as their inclination is contrary to the inclination of shear cracks. The connection between the support and the first floor slab

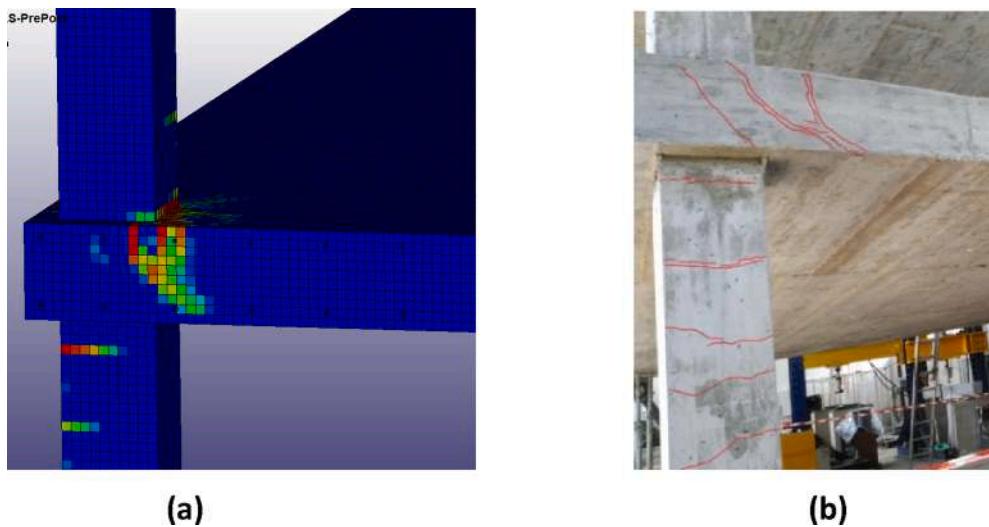
Fig. 16. Test (a) and FEM (b) column-slab crack pattern.

shows also such torsional cracks (see Fig. 16). This is a type of action for which the connection is not designed and failure of this connection could potentially lead to collapse of the structure. This type of cracking pattern, however does not develop at the connection between the column and the top slab because the rotation of the slab is accommodated by more extensive cracking (and possibly yielding of the reinforcement) at the top of the column (see Fig. 17). The horizontal cracks in the support at the top part of the top column were larger than those observed at the bottom supports. This different behaviour is due to the difference in axial force as the compression force in the bottom column is roughly twice the compression in the top columns.

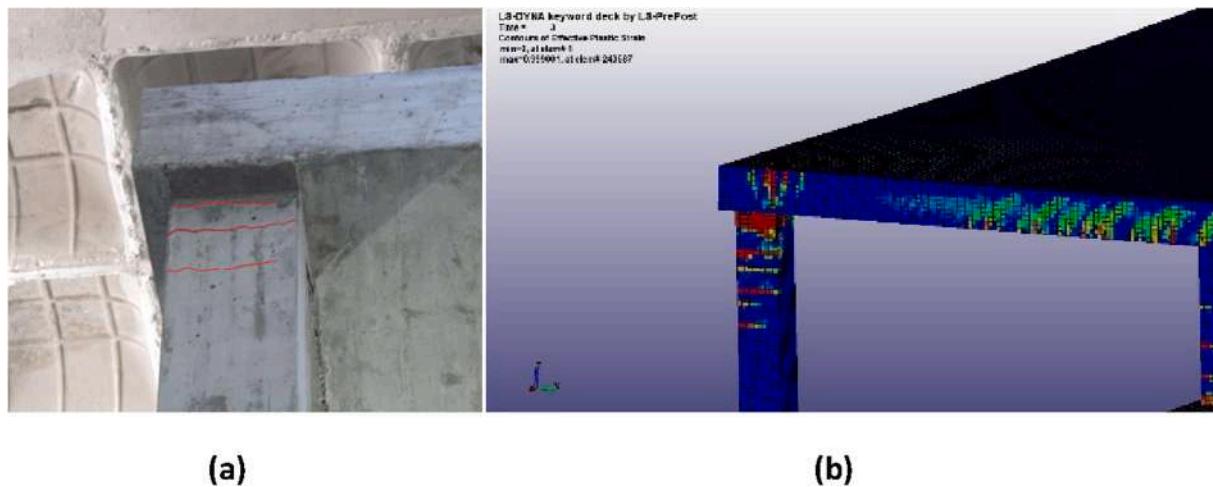
Fig. 17. Test (a) and FEM (b) top slab crack pattern.

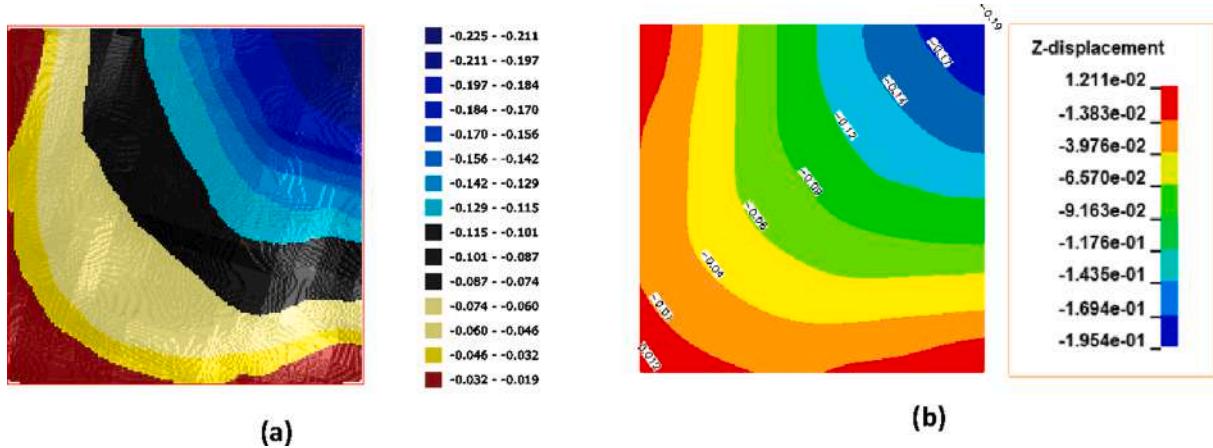
Fig. 18. Test (a) and FEM (b) Top Slab Deflection.

Fig. 18 and Fig. 19 show a comparison between the deflections measured by laser-scan and the prediction of the model. It can be seen that both the shapes and values obtained by the simulation are very close to those of the test. It is also worth noting that the value of the

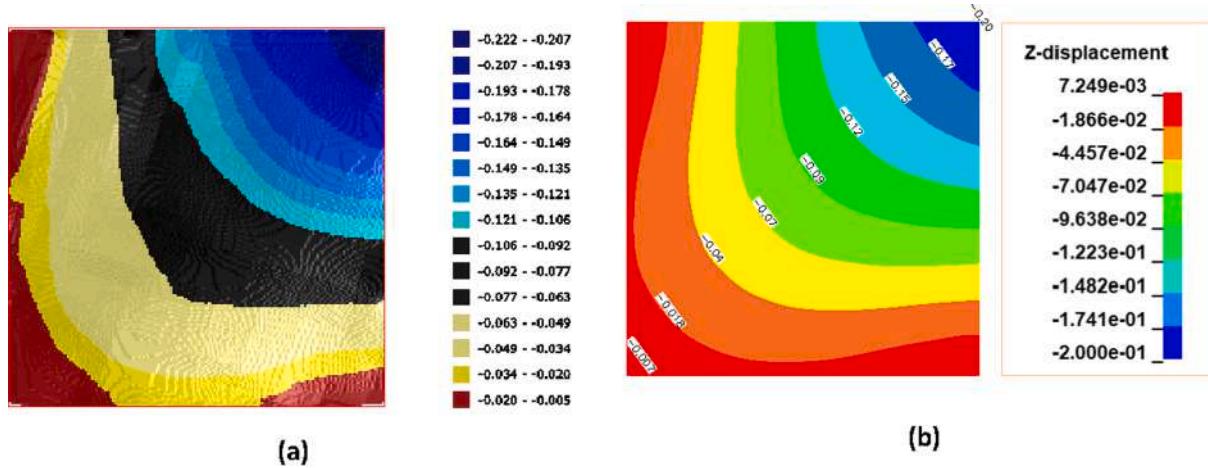
Fig. 19. Test (a) and FEM (b) Bottom Slab Deflection.

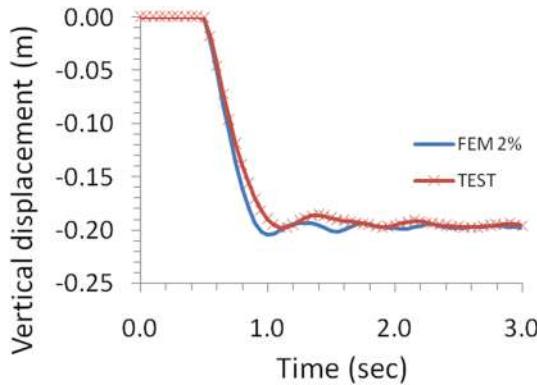
Fig. 20. Comparison of the displacement history from FEM model and test results.

Fig. 20 shows a comparison between the time history of displacements measured by DIC and the prediction of the FEM model using a reasonable damping index of 2%. This damping ratio has been selected due to the relatively small damage observed on the specimen. Cracks were small enough to be admissible in SLS. This damping index is within the range recommended by EN 1991-2 [8] for reinforced concrete railway bridges. It can be seen that there is good agreement between experimental and model results. A very interesting fact that can be derived from this figure is that the impact factor is quite low, as can be seen from the small magnitude of the oscillation of deflections after the collapse of the column. Reasons for this can be related to the asymmetry in stiffness as the slab is cracked when deflecting downwards, but not when deflecting upwards.

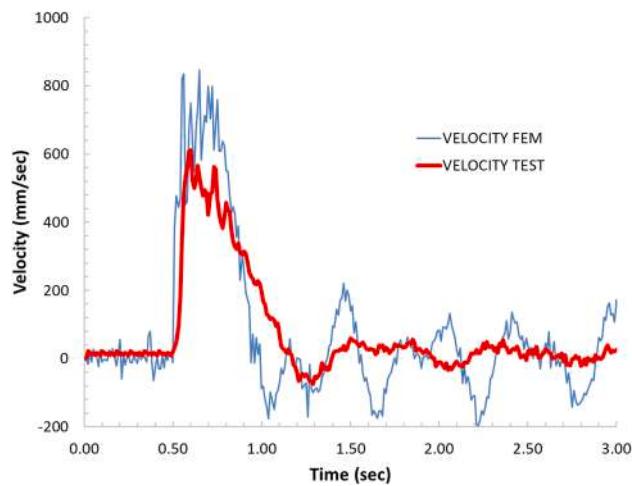
Fig. 21. Velocity of corner of slab. Comparison between experimental values and values obtained by FEM. The test value is obtained by numerical derivation of the deflection results obtained by DIC.

into kinetic energy, increasing the velocity of the structural system (see Fig. 21). As the structure deflects, the kinetic energy decreases, and the structure absorbs the potential energy of gravity loads in form of elastic and inelastic energy. The maximum dynamic response is reached when the work done by gravity loads is equal to the stored strain energy of the system, and hence the kinetic energy is zero (see Fig. 22).

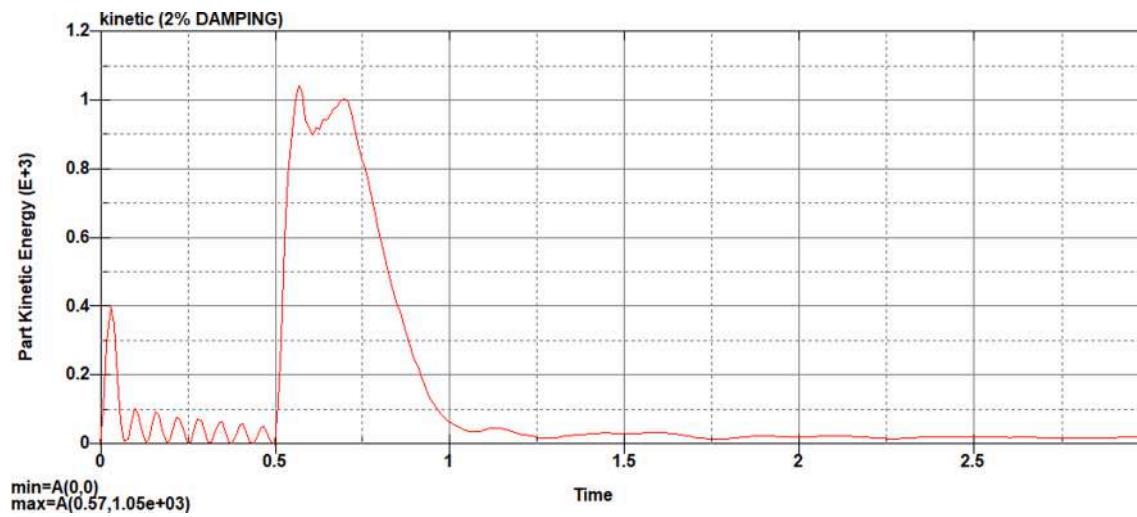
Fig. 22. Kinetic Energy of the structure determined by FEM analysis for 2% damping.

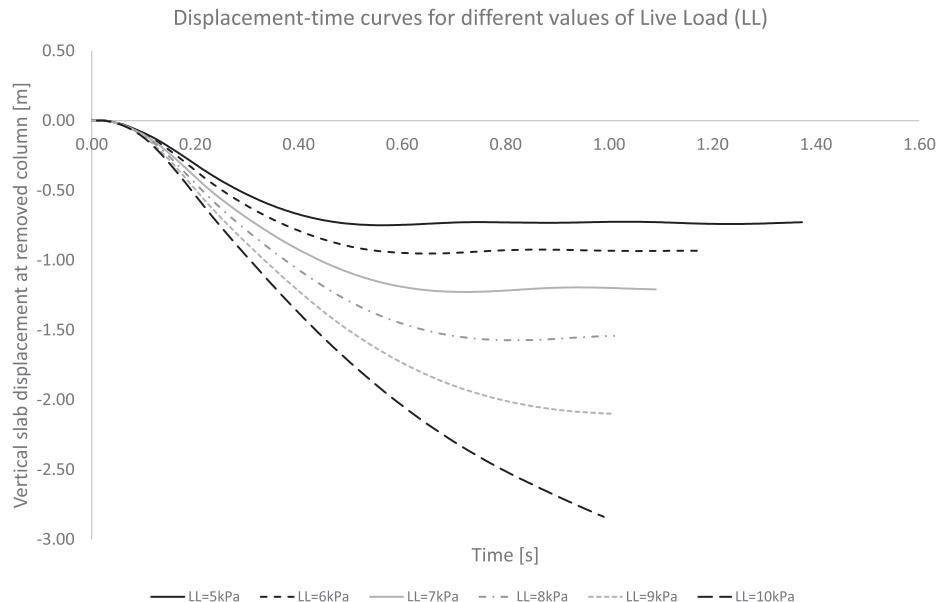
Fig. 23. Vertical slab displacement at location of removed column versus time for different values of live loads.

In order to be able to establish a basis of comparison with other tests, numerical analyses have been undertaken to try to assess the maximum load that could be carried by the structure. For this both slabs have been loaded with increasing values of live loads going from 5 kPa to 10 kPa. Fig. 23 shows the result. The structure seems to be stable up to a live load value of 9 kPa. For a larger value the slab would touch the floor as the deflection would exceed the height of the columns. The ratio between

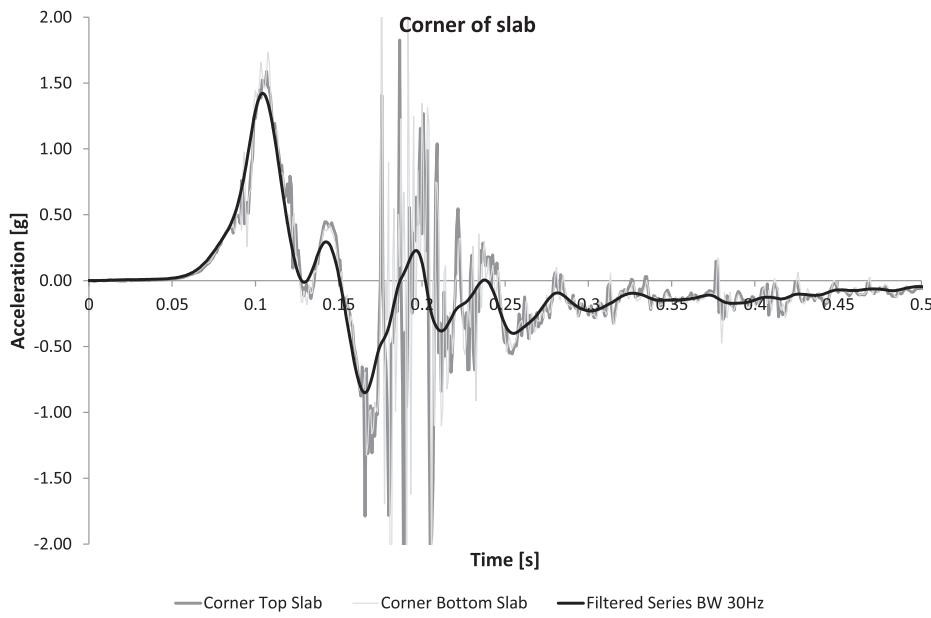
Fig. 24. Measured accelerations at the corner of the slab (over the removed column).

Fig. 24 and Fig. 25 show the measured accelerations at the corner and centre of the slab, respectively for both bottom and top slab. It can be seen that the measurements at both slabs are very coherent, so that both slabs have practically identical movements. This is also an indication of the correctness of the measurements. Notice that maximum accelerations when the slab is falling are greater than 1 g, which would be the maximum expected acceleration for the case of a free-falling body. The reason for this is that, with respect to its final equilibrium position, the slab is initially deformed in the upwards direction and has therefore stored strain energy. When the support fails, the slab is subjected to both gravity (which will accelerate the slab an amount g) and to the release of the stored strain energy, thereby explaining the initial acceleration peak of the corner .

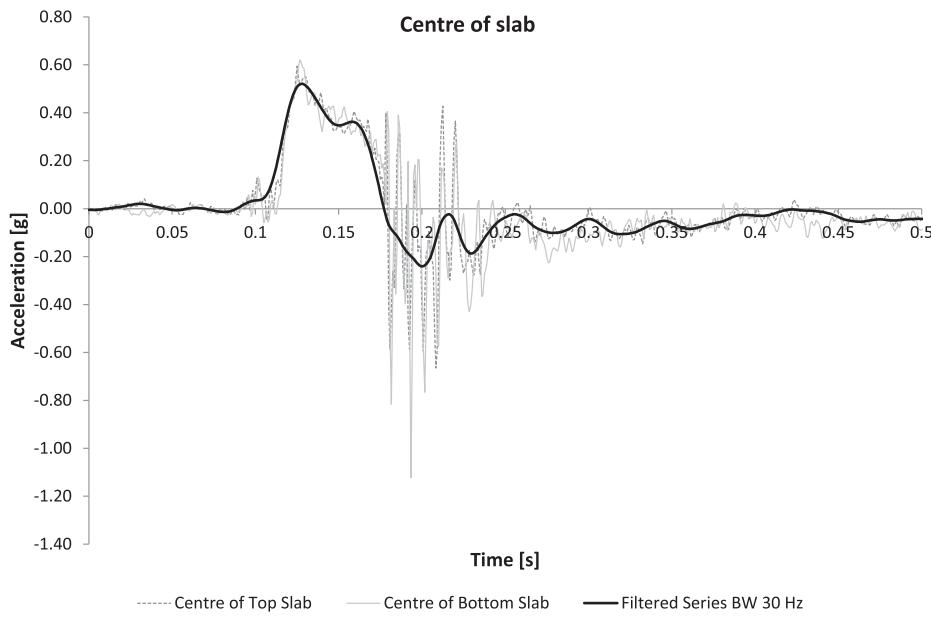
Fig. 25. Measured accelerations at the center of the slabs.
