# Are Electric Cars Safe? A Descriptive Analysis of the first collisions reported in Spain

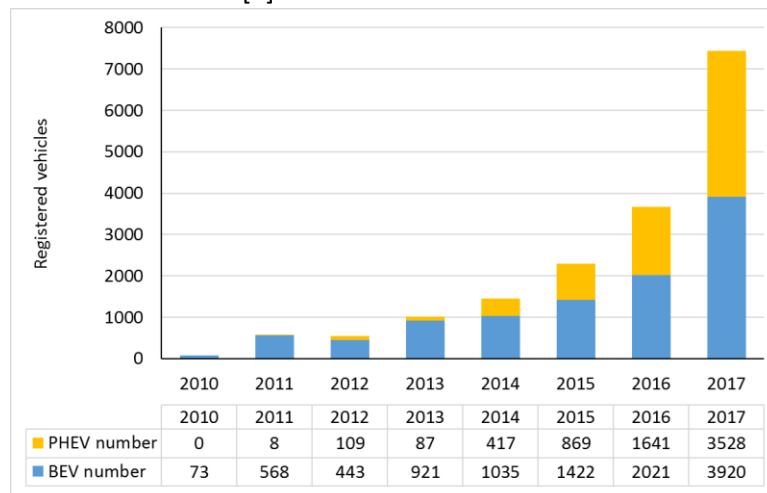
Fig. 1. Registration of electric vehicles in Spain (2010–2017). PHEV: plug-in hybrid electric vehicle; BEV: battery electric vehicle [3].

In January 2018, 5,993 hybrid vehicles and 922 full electric vehicles were registered in Spain. This accounts for 6.5% of all vehicles registered that month and is a 52% increase compared to January 2017 [1]. The data reflect a trend that has been growing exponentially over the last seven years in Spain (Fig. 1). Nevertheless, PEV (plug-in vehicles, including both hybrid PHEV and battery BEV) represented only 0.6% of the market share of all passenger cars in Spain in 2017, well behind other European countries, such as Sweden, Belgium, Finland or The Netherlands, where PEV passenger cars account for more than 1.5% of the market share. In the whole of the EU, the percentage of PEV passenger car registrations was 1.4% and, similar to Spain, there is a growing trend of the registration of these vehicles in the 28 EU Member States [2].

Paralleling the market penetration of BEV shown in Fig. 1, the number of crashes involving BEV has increased over the last three years from two cases in 2014, to six cases in 2015, to 46 cases in 2016. The rate of involvement of BEV in crashes has grown steadily: 0.06% (2014), 0.13% (2015) and 0.51% (2016). All these BEV were registered in 2012 or later. Unfortunately, for almost 75% of the BEV crashes reported in 2016, there is missing data that precludes drawing information from the victims involved in those crashes.

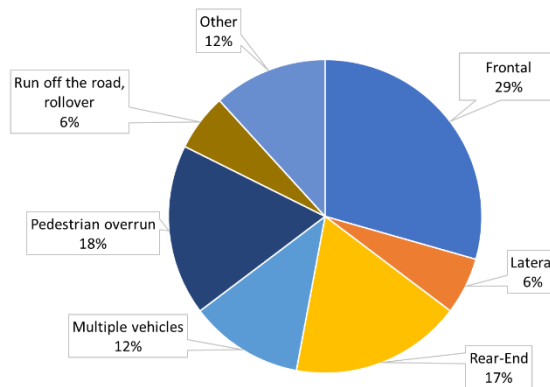
Fig. 2. Distribution of crash configuration for BEV in Spain, 2014–2016.

Although the majority of BEV crashes occurred in urban areas, 25% of BEV crashes took place in conventional roads outside of cities. There was one pedestrian collision in each of the three analysed years. Most BEV crashes were head-on crashes, although there was also a significant number of rear-end collisions. The distribution of crash configuration is shown in Fig. 2.
